Manhole Inspection Summary

Manhole # S37AA_020MH

Insp Date: **11/20/08 11:00 AM**

Location Address: **cross from 540 e monument st**

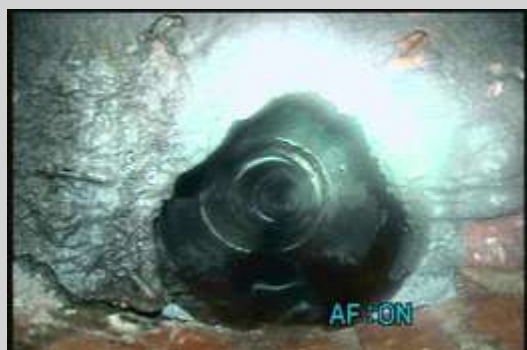
12 O'Clock Outflow

8 in. Circular Gravity Sewer
Pipe Out @ 12 O'Clock

Pipe Material: **Clay** ☐ Pipe Lined

Infiltration: **None** Pipe Seal Cond: **Unknown**
